ISCO CASE STUDY: USE OF HIGH pH ACTIVATED SODIUM PERSULFATE, GAS STATION SITE, MILPITAS, CA

INTRODUCTION

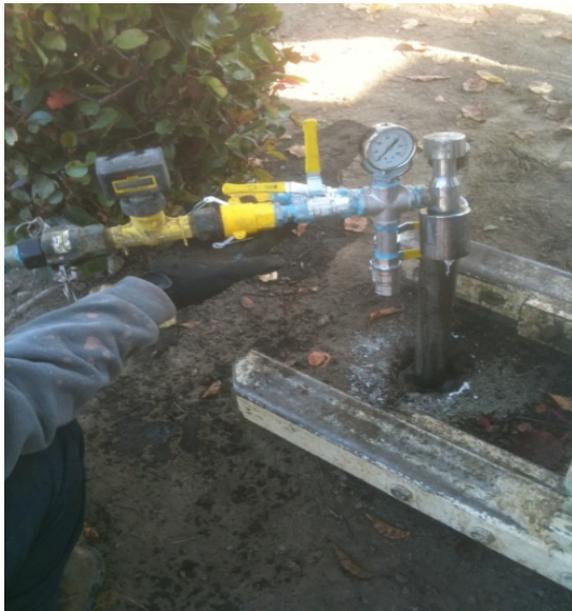
JAG Consulting Group recently performed a high pH activated sodium persulfate treatment at an active gas station site located in Milpitas, CA. Sodium hydroxide (25%) was used to induce the high pH conditions. Due to the shallow groundwater conditions (5 feet bgs), direct push injection was selected as a cost effective means to inject the chemicals.

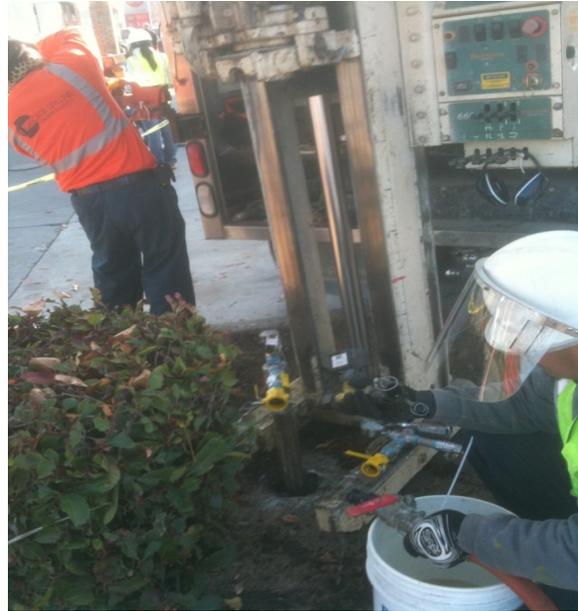
Over the course of five days, a total of 2,300 gallons of sodium hydroxide and 4,500 gallons of sodium persulfate were injected into the subsurface. Low

injection pressures (less than 35 psi) and moderate injection flow rates (5 to 9 gpm) were applied in an effort to minimize the potential for chemical daylighting. As a result, no daylighting occurred during the injections.
